The Advantages Of A Varying Length Segmented Foil Tape In Category 6A UTP Cable

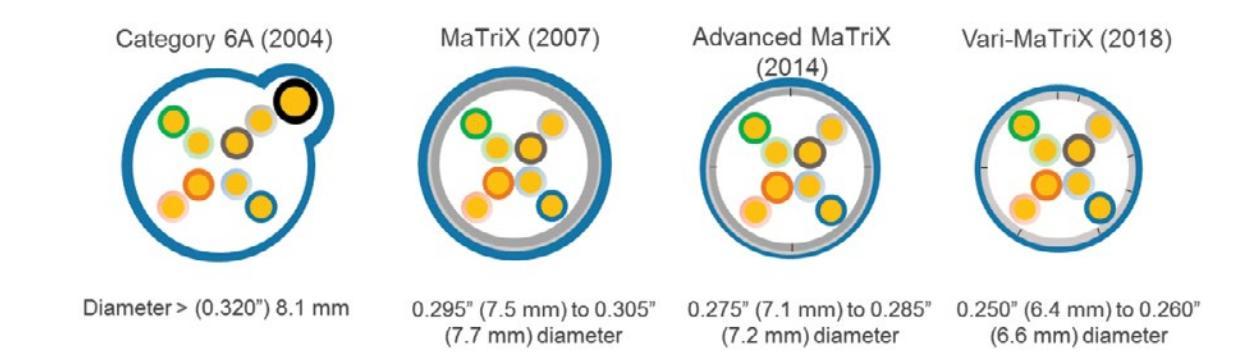
Figure 1. Category 6A Cable History at Panduit.

Size constraints of traditional Category 6A UTP (unshielded) cable designs are typically driven by the alien crosstalk requirement. With Panduit's Vari-MaTriX design, the discontinuous metallic foil barrier provides far superior alien crosstalk performance, thereby removing the traditional constraints on cable size. Instead of alien crosstalk dictating minimum cable sizes, the Vari-MaTriX cable size is limited primarily by the wire gauge of the internal conductors. The result is a Category 6A cable similar in size to lower category cables and alien crosstalk performance superior to traditional UTP. The history of Category 6A cable sizes at Panduit is shown in Figure 1.

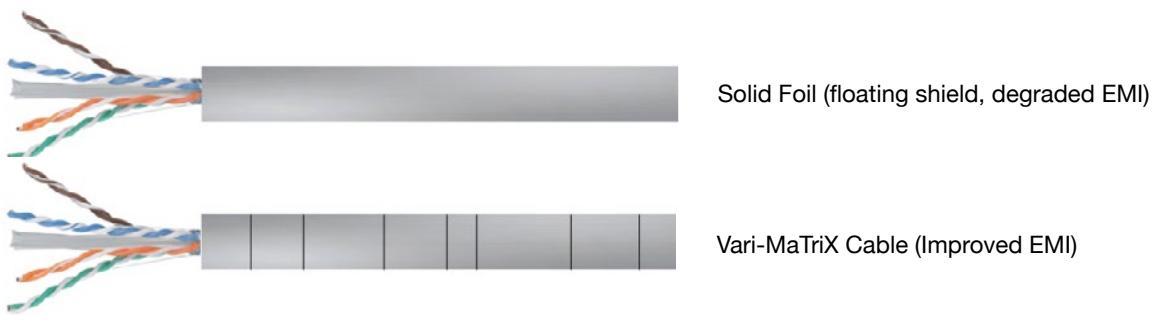
Figure 2. Example of Solid Foil and Vari-MaTriX Cable.

Others in the industry have since incorporated metallic barriers in their UTP cable designs to take advantage of the size and alien crosstalk enhancements. However, some of these cables implement a continuous foil barrier (floating shield) which can degrade the electromagnetic immunity performance of a system due to the foil being unterminated. Using this type of cable construction in a UTP channel equates to using an unterminated F/UTP shielded cable (foil around a twisted pair). Large foil discontinuities are created at each UTP jack and plug interface because the continuous shield does not get terminated. Some in the industry have incorporated discontinuous metallic barriers with fixed length discontinuous segments. While these designs may be an improvement over continuous unterminated foil barriers with respect to immunity, they can still be prone to specific in-band and/or out-of-band EMC weaknesses depending on the fixed length of the discontinuous segments. The discontinuous and variable length nature of the metallic barrier in Panduit's Vari-MaTriX cable prevents any degradation to the EMC performance of a system whether in-band or out-of-band. A comparison of the foil designs is shown in Figure 2.

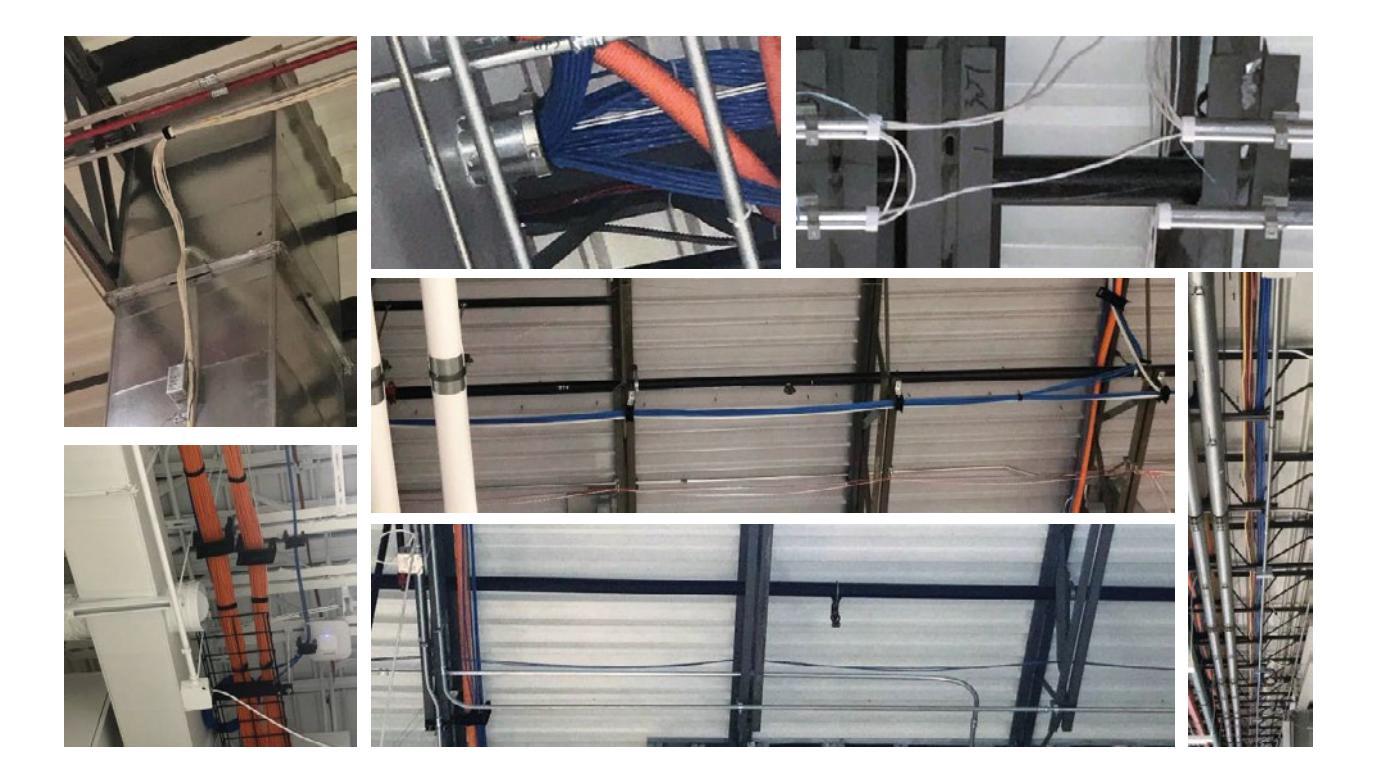
Figure 3. Example of metallic surfaces that can create impedance discontinuities.

Building an unshielded channel with unshielded plugs, unshielded connectors, and a cable which incorporates a continuous metallic outer foil essentially creates the worst-case scenario for shielded systems described on page 6. While networks can operate successfully with UTP cabling systems in the EMC environments found in enterprise and data center locations, implementing an unterminated shielded cabling system in those environments introduces new EMC weaknesses that can disrupt communication over the network. In the presence of EMI, current can be induced in the metallic foil surrounding the cable. Unlike the shielded systems where this current is shunted to ground due to the low impedance continuity of the shield throughout the channel, the induced current will be reflected at each UTP connector and/or plug interface where the continuity of the shield ends. Reflections will also occur at locations along the length of the cable where the common mode impedance of the unterminated shield changes. Metallic surfaces in close proximity to the cable will lower the impedance at these locations. Examples of these metallic surfaces are ladder racks, HVAC ducting, conduit, and structural beams as shown in Figure 3. These impedance changes will cause a portion of the induced current to be reflected at the location of the discontinuity.

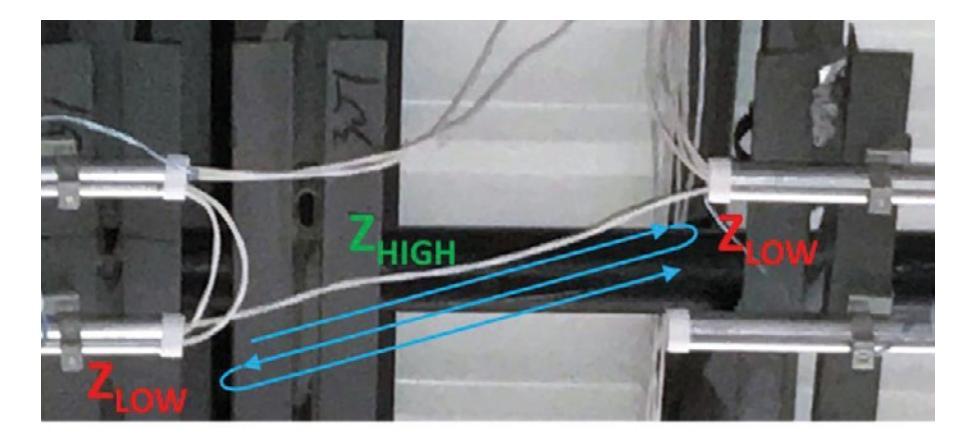
Figure 4. Impedance discontinuities creating a standing wave, example 1.

A standing wave can be built up by the current reflecting back and forth between at least two of these discontinuities. Like a dipole antenna, the combination of the successive reflections caused by the shield discontinuities will give rise to a standing wave at a frequency whose half wavelength is equal to the distance between the discontinuities. Figure 4 and Figure 5 highlight examples of where the impedance discontinuities and multiple reflections can occur. Nearby metallic surfaces such as equipment racks and cabinets can also act as a reference plane for the current induced on the metallic foil serving to enhance the resonant behavior of the unterminated foil. This standing wave on the unterminated foil will occur when the EMI incident on the cable is at or close to the aforementioned frequency. As a result, the unterminated shield can have voltage maxima and minima along the length of the foil between successive discontinuities. A corresponding noise voltage will be induced onto the conductors within the cable at the standing wave frequency due to the strong capacitive coupling between the foil and the conductors. Imbalances in the cabling channel will convert a portion of this noise into a differential signal, while the remaining noise will remain as a common mode signal. This mechanism by which noise couples into the cabling channel from a source of EMI is unique to those cables implementing unterminated foil barriers. Traditional UTP cabling channels will not be susceptible to this phenomenon in the same way because there is no unterminated conductor to support a standing wave.

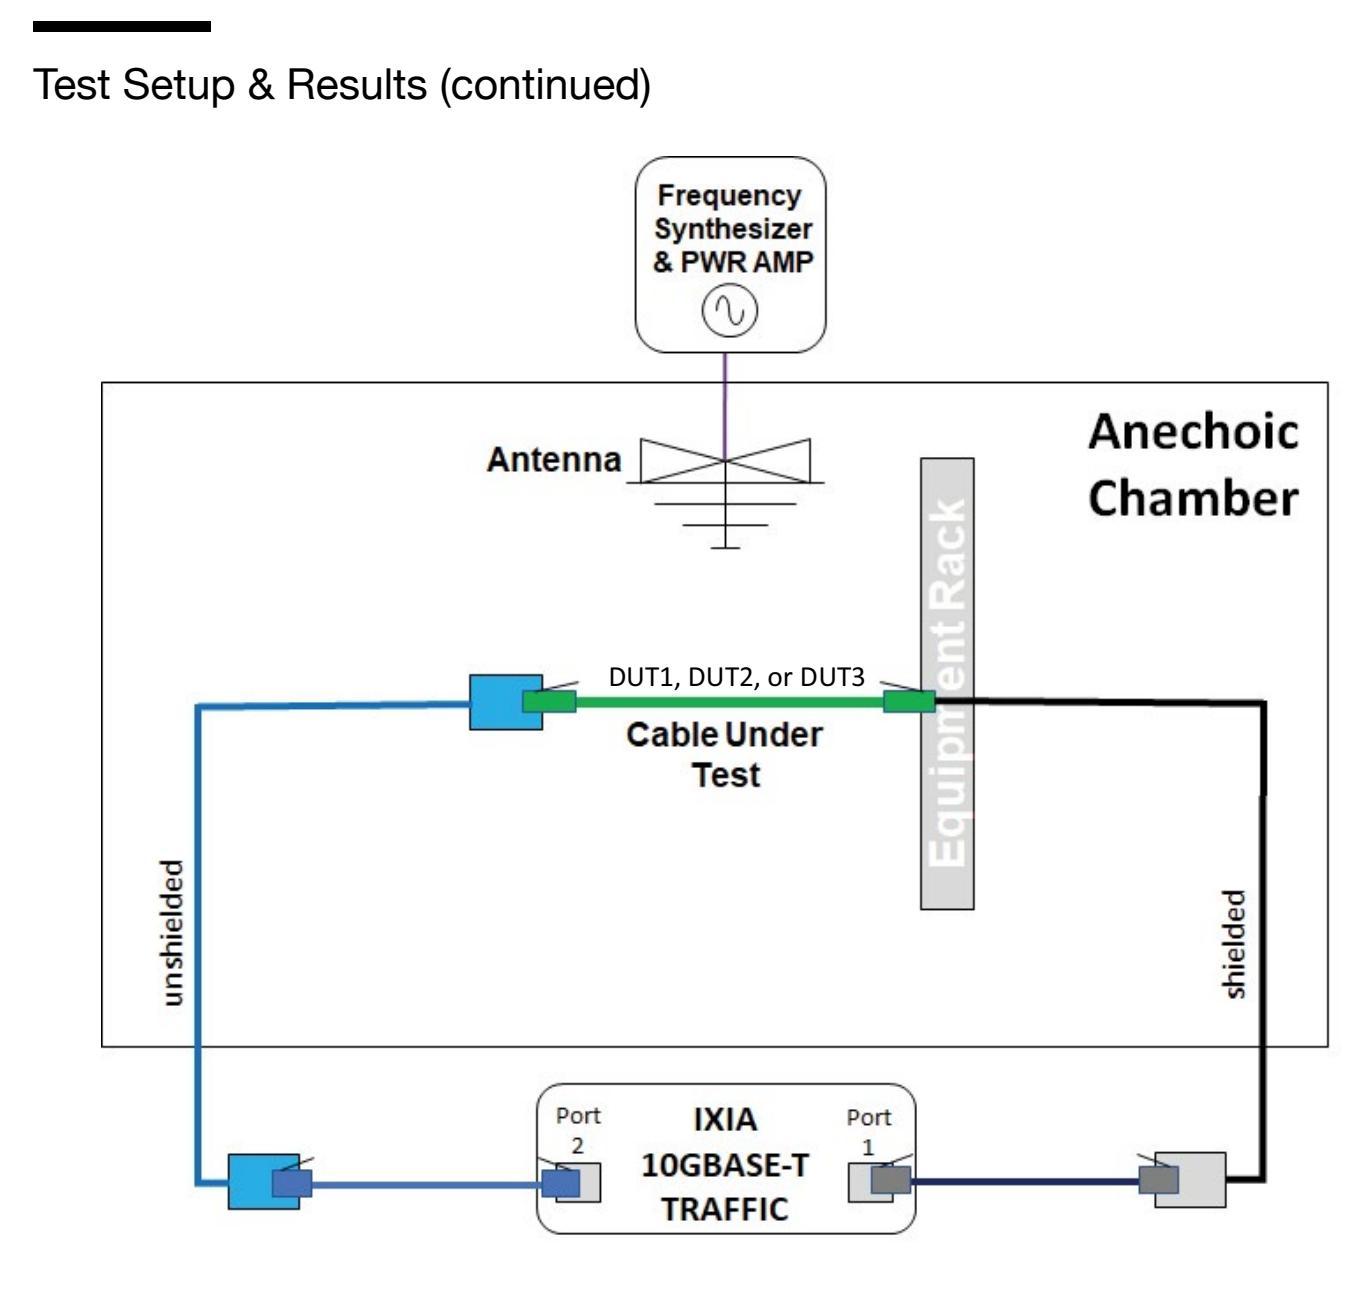
Figure 6. Test setup used for evaluating solid foil and Vari-MaTriX cable.

The test was configured to emulate one possible real-world application environment. Per Figure 6, an IXIA 10GBASE-T line card (LSM10GXM2GBT-01) was used to generate and monitor the 10GBASE-T traffic bidirectionally across the channel. One port of the IXIA traffic generator was connected to a shielded port on the equipment rack inside the anechoic chamber through shielded cabling. All shield connections from the IXIA box to the equipment rack in the anechoic chamber were continuous and properly terminated with best practices. This connection serves to bring the data source (IXIA) to the equipment rack without having to position the IXIA physically inside the anechoic chamber where it would be exposed to the EMI. The portion of the channel under test being exposed to EMI was then connected to the equipment rack.

The test was conducted by comparing the performance of 1m horizontal cables terminated with unshielded plugs (similar to a patch cord). In each scenario, the cable type was changed to be the types under evaluation (UTP cable with no foil, solid foil, and Vari-MaTriX cable). These devices under test (DUT) were connected to a UTP jack and 10m of UTP horizontal cable which was routed back out of the anechoic chamber. A 2m UTP patch cord completed the connection from the horizontal cable to the second port on the IXIA traffic generator as shown in Figure 6. The specific DUTs are:

- DUT1: 1m true UTP patch cord
- DUT2: 1m patch cord made with a floating unterminated foil around the conductors. In this configuration, there is a 1m length between shield discontinuities.
- DUT3: 1m patch cord made with the Vari-MaTriX cable which uses a metallic foil barrier with variable length discontinuities in the foil.

Using a signal generator, power amplifier, and log periodic antenna, the frequency and field strength of the EMI can be accurately controlled. Conducting the test in a fully anechoic chamber allows the polarization of the interfering signal to be controlled relative to the position of the cable under test. This is a key variable associated with EMI and impossible to predict in every real-world environment. The worst-case scenario arises when the electric field of the interfering wave is aligned with the position of the cable as the induced current in the cable will be maximized. During this experiment, the cable under test was positioned horizontally across a table to align with the horizontal polarization of the log periodic antenna. The fully populated equipment rack creates a metallic surface which will act as a reference plane for the current induced on the cable under test. The position and orientation of the DUTs exposed to the EMI and all other channel components was identical when testing DUT1, DUT2, and DUT3 to ensure an accurate comparison between the test conditions.

With 10GBASE-T traffic running bidirectionally across the channel, the frequency was swept from 101 MHz to 131 MHz in 2 MHz intervals. At each frequency point, the field strength of the EMI was increased until the onset of packet errors was captured by the IXIA traffic tester. The field strength was then increased further until the interference was strong enough to cause the link to drop, interrupting all 10GBASE-T communication. The power levels at both "packet error onset" and "link drop" were recorded at each frequency for all three DUTs.

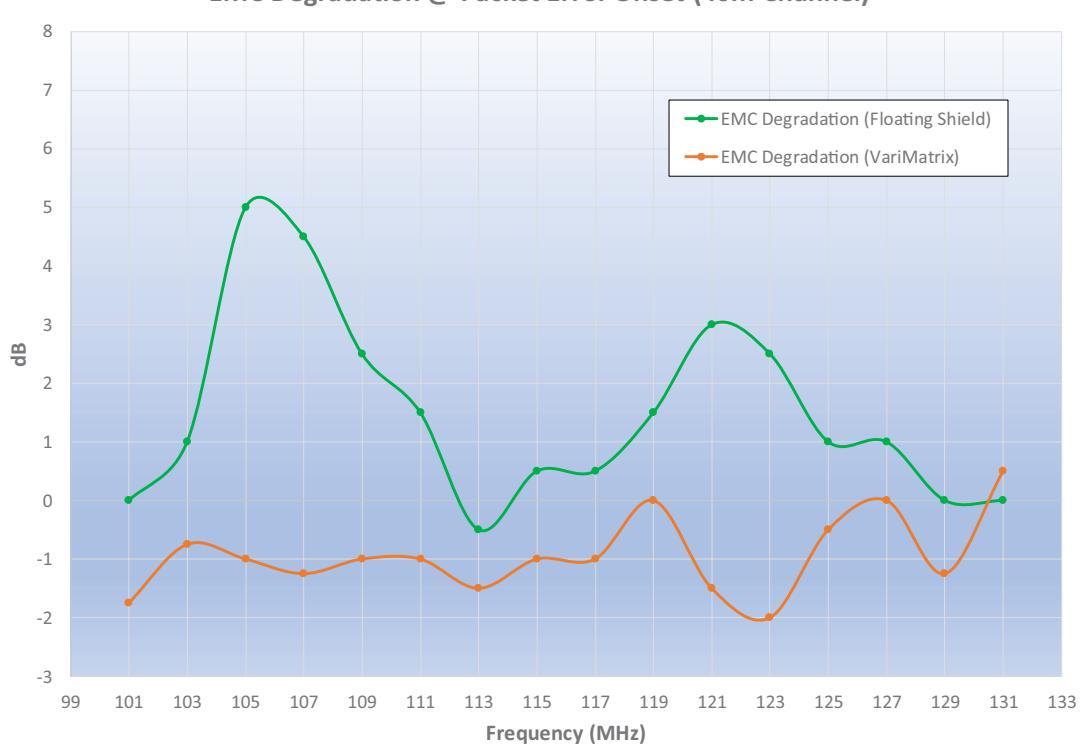
EMC Degradation @ Packet Error Onset (40m Channel)

A comparison of the electromagnetic susceptibility between the three DUTs is plotted in Figure 7 and Figure 8 below. Figure 7 shows the EMC degradation at the onset of packet errors compared to traditional UTP cable for both floating shield and Vari-MaTriX cable construction. The maximum degradation of slightly more than 5dB was observed at approximately 105 MHz with DUT2 (Floating Shield). The half wavelength of a signal propagating on a cable at 105 MHz is approximately 1m. This is the exact length between discontinuities in the floating shield. Due to the standing wave induced on the floating shield by interference at 105 MHz, the susceptibility of the 10GBASE-T link was 5dB worse than the traditional UTP cable. Figure 8 shows the EMC degradation at link drop compared to traditional UTP cable for both floating shield and Vari-MaTriX cable construction. Again, at approximately 105 MHz the worst-case degradation of 6dB was observed with DUT2 (Floating Shield), demonstrating that unterminated foil degrades the susceptibility of the channel compared to traditional UTP. A 6dB degradation equates to a reduction in electromagnetic immunity by a factor of 2. In comparison, there was no EMC degradation with Vari-Matrix cable for either the onset of packet errors or the link drop condition.

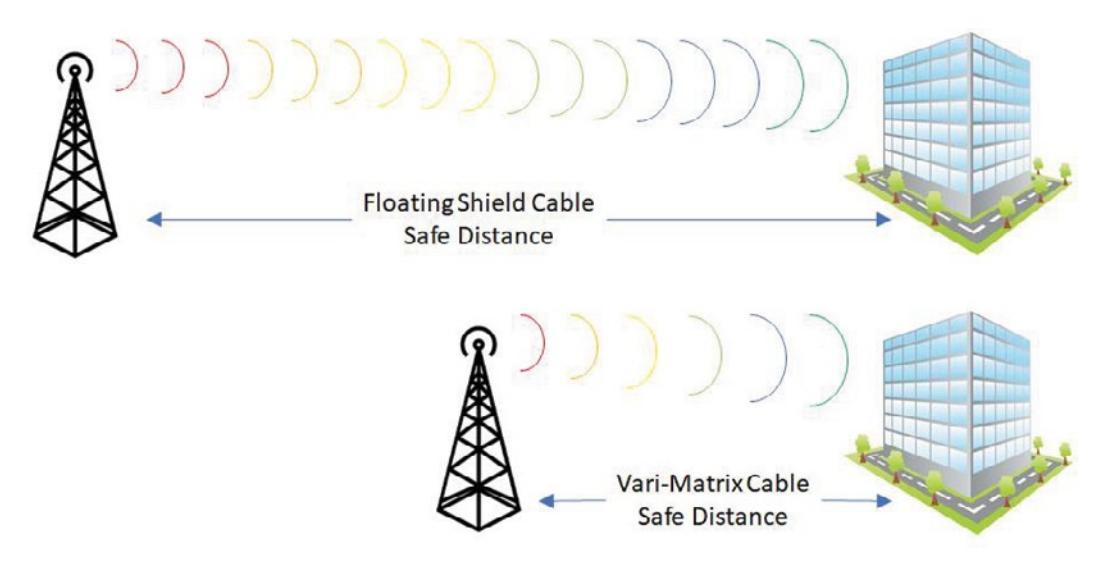
Figure 9. Vari-MaTriX EMC safe distance from EMI source reduced by 2X.

To translate this factor of 2 to a real-world example as shown in Figure 9, consider a source of EMI at 105 MHz, such as FM radio broadcast, that produces a safe level of EMI in a data center when it is located at least two miles away and Vari-MaTriX cabling channels are installed. If cabling with unterminated continuous foil barriers were installed, the safe distance to the FM broadcast tower would now be at least four miles (2X) away. The "safe" distance implies that even when all the variables involved with susceptibility align in the worst-case fashion, the network will not be affected by the interfering noise.

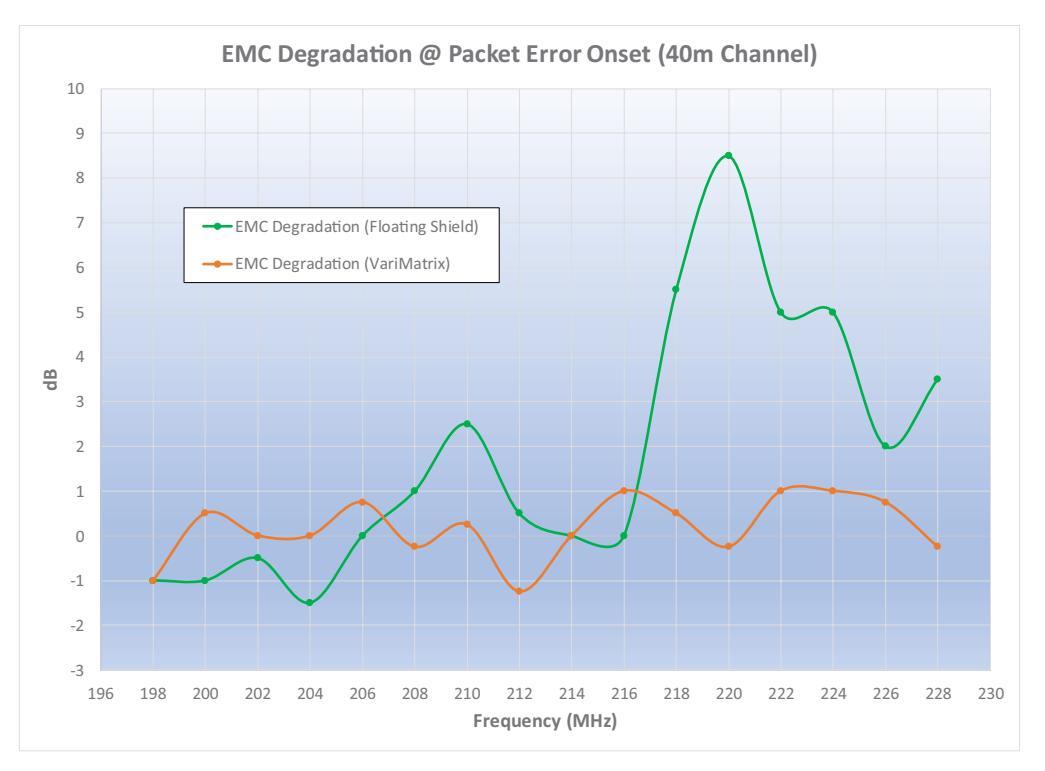
Figure 10. Floating Shielded vs Vari-MaTriX EMC Degradation at Error Onset, Device Under Test at 0.5m.

A comparison of the electromagnetic susceptibility between the three DUTs is plotted in Figure 10 and Figure 11. Figure 10 shows the EMC degradation at the onset of packet errors compared to traditional UTP cable for both floating shield and Vari-Matrix cable construction. The maximum degradation of 8.5dB was observed at approximately 220 MHz with DUT2 (Floating Shield). The half wavelength of a signal propagating on a cable at 220 MHz is approximately 1m. This is the exact length between discontinuities in the floating shield Due to the standing wave induced on the floating shield by interference at 220 MHz, the susceptibility of the 10GBASE-T link was 8.5dB worse than the traditional UTP cable. Figure 11 shows the EMC degradation at link drop compared to traditional UTP cable for both floating shield and Vari-Matrix cable construction. Again, at approximately 220 MHz the worst-case degradation of 9.5dB was observed with DUT2 (Floating Shield), demonstrating that unterminated foil degrades the susceptibility of the channel compared to traditional UTP. A 9.5dB degradation equates to a reduction in electromagnetic immunity by a factor of 3. In comparison, there was no EMC degradation with Vari-MaTrIX cable for either the onset of packet errors or the link drop condition. Just as in the previous example, this factor of 3 requires that the safe distance from an EMI source at 220 MHz is three times further when cables with unterminated continuous foil barriers are used compared to Vari-MaTriX cable or traditional UTP cable.

To further validate this phenomenon, another test was done with shorter DUTs of approximately 0.5m. With 10GBASE-T traffic running bidirectionally across the channel, the frequency was swept from 198 MHz to 228 MHz in 2 MHz intervals. At each frequency point, the field strength of the EMI was increased until the onset of packet errors was captured by the IXIA traffic tester. The field strength was then increased further until the interference was strong enough to cause the link to drop, interrupting all 10GBASE-T communication. The power levels at both "packet error onset" and "link drop" were recorded at each frequency for all three DUTs.
